**Flood Control Project Maintenance  
Levee Inspections**

**Maintenance Issue Types Only, Levee Inspection Report By Mile - Fall 2019**

**Sacramento Maintenance Yard Putah Creek**

Waterway	Bank	Unit Miles	Inspection Start/End	Inspector
Unit No. 01 Putah Creek or North Levee	Left	8.79	10/08/2019 10/08/2019	David Julian

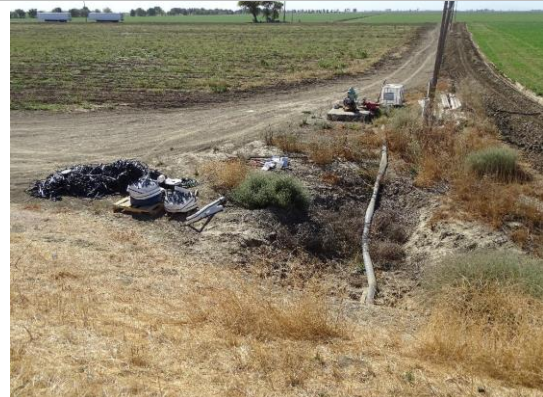
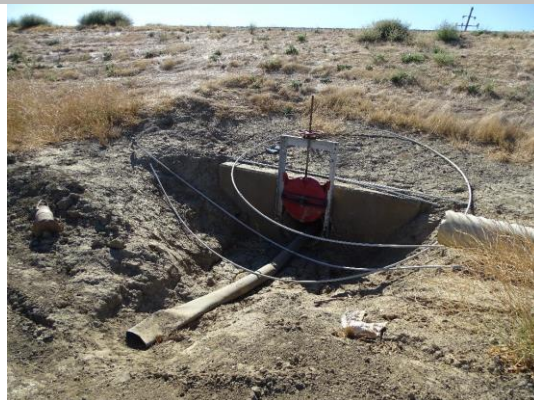
Photo 2 of 3 : UCIP\_FA\_2019\_55419\_81629.jpg

View of LS from levee crown

Item	DRAFT DWR UCIP LMA Responsibility		38.516000 °	38.516000 °								
			-121.760500 °	-121.760500 °								
DWR ID	16636											
Comment Code												
Inspector Comment												
DS_ID:16636 FS_ID:55419 EP_NO: 10279 Repair Type: Urgent Crossing Status: Found UCIP Comments: 10/21/2019 A 6-inch hose connected to a water well on LS runs through a drainage pipe from LS to WS. Slide gate cannot be closed properly to prevent flooding on LS. Remove hose. (O.Yakimov - DWR UCIP)05/22/2013 Pipe was cleaned by the owner and 6 in pipe is still being used. (C. Lund - DWR Sacramento Yard) 04/05/2012 Pipe needs to be cleared of sedimentation. (W. Wylie - DWR UCIP) FIELD_STRUCT_DESC: 24-inch CIPP-lined corrugated metal drainage pipe through the levee, 14 feet below the crown. Slide gate on the waterside (WS) end. Concrete headwall on landside (LS) end. (name change for existing 24-inch drainpipe and slide gate on WS [HLM 5.89] issued under Permit No. 10279-1, 2012 - Elizabeth Dankworth and Michelle Christison; 24-inch pipe [HLM 5.89] authorized under Automatic Board Order (ABO) issued as Permit No. 10279, 1974 - Carmelita Watkins). [Additional Reference(s): DWR Levee Log, 2005 (HLM 5.89). USACE Sacramento O&M Manual, Unit 119, December 1952, Revised 29 Dec 2016, (Station 193+00 PCT). USACE As-Built Drawing No. 50-04-2396, Revision 4, pdf page 25, Sheet 9, December 1947]. FS Date: 10/21/2019 1:39:07 PM

WS slope with headwall and slide gate

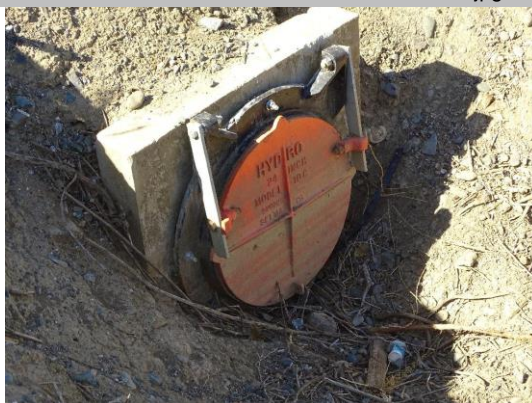
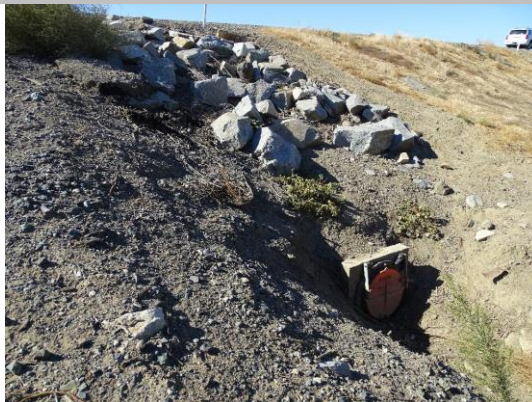
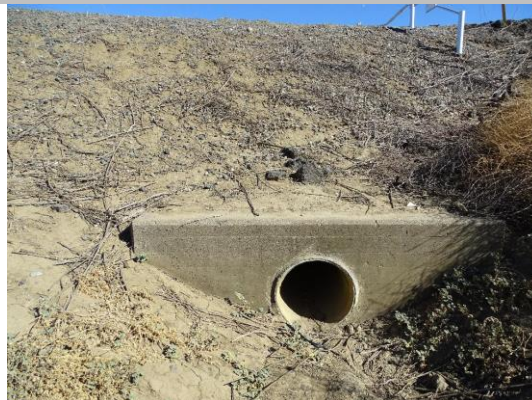
Photo 1 of 3 : UCIP\_FA\_2019\_55446\_81718.jpg

Headwall and flap gate

View of WS slope and flap gate at levee toe

Comment Code						
Inspector Comment						
DS_ID:16639 FS_ID:55446 EP_NO: 10278 Repair Type: Non-Urgent Crossing Status: Found UCIP Comments: 10/21/2019 No issues recorded during inspection (O.Yakimov - DWR UCIP)07/12/2019 After reviewing the USACE O&M manual as-builts there is no reference to this 24-inch pipe. Will need to coordinate with previous UCIP inspector to determine if additional information is available to tie pipe to USACE O&M manual. (O. Magana - DWR UCIP) 05/22/2013 All material was removed. (C. Lund - DWR Sacramento Yard) 04/05/2012 Flap gate blocked by minor amounts of sedimentation. (W. Wylie - DWR UCIP) FIELD_STRUCT_DESC: 24-inch CIPP-lined corrugated metal drainage pipe through the levee, 15 feet below the crown. Flap gate on waterside (WS) end. Headwall on the landside (LS). (24-inch pipe [HLM 5.99] authorized under Automatic Board Order (ABO) issued as Permit No. 10278, 1974 - Southern Pacific Transportation Company). [Additional Reference(s): DWR Levee Log, 2005. USACE Sacramento O&M Manual 119, December 1952]. FS Date: 10/21/2019 1:46:38 PM

LS levee slope, headwall and pipe

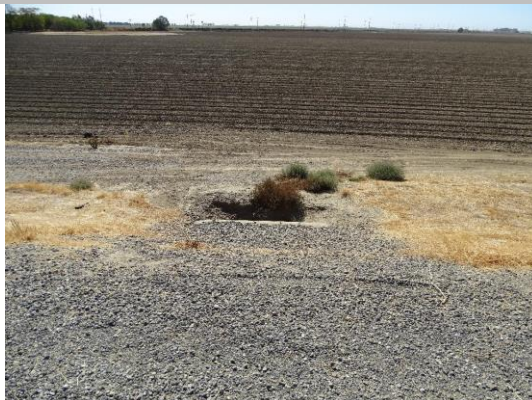
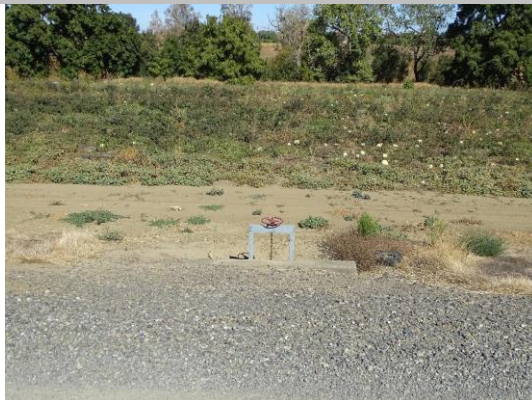
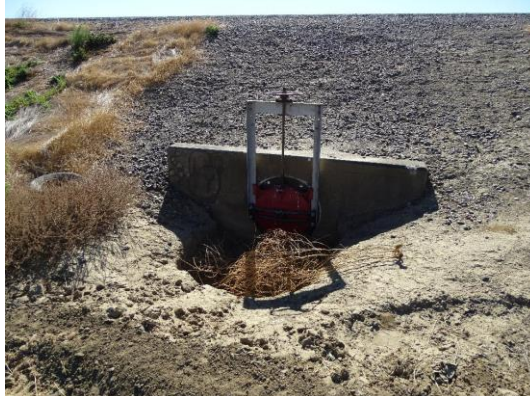
Photo 1 of 3 : UCIP\_FA\_2019\_55448\_81724.jpg

View of LS looking from levee crown

View of WS looking from levee crown

Comment Code						
Inspector Comment						
DS_ID:16641 FS_ID:55448 EP_NO: 10265 Repair Type: Non-Urgent Crossing Status: Found UCIP Comments: 10/21/2019 No issues recorded during inspection (O.Yakimov - DWR UCIP)04/05/2012 Pipe has some sedimentation buildup internally. (W. Wylie - DWR UCIP) FIELD_STRUCT_DESC: 24-inch CIPP-lined corrugated metal drainage pipe through the levee, 11 feet below the crown. Slide gate on the waterside (WS) end. Concrete headwall on the landside (LS) end. (24-inch pipe [HLM 6.19] authorized under Automatic Board Order (ABO) issued as Permit No. 10265, 1974 - State of California, Division of Highways. Also included in Automatic Board Order (ABO) issued as Permit No. 11296, 1974 - Capitol National Bank of Sacramento and Crocker Citizens National Bank). [Additional Reference(s): DWR Levee Log, 2005 (HLM 6.19). USACE Sacramento O&M Manual, Unit 119, December 1952, Revised 29 Dec 2016, (Station 208+00 PCT). USACE As-Built Drawing No. 50-04-2396, Revision 4, pdf page 25, Sheet 9, December 1947]. FS Date: 10/21/2019 2:08:05 PM

WS levee slope, headwall, and slide gate

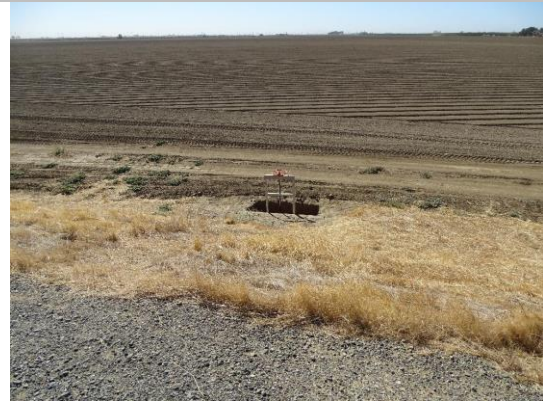
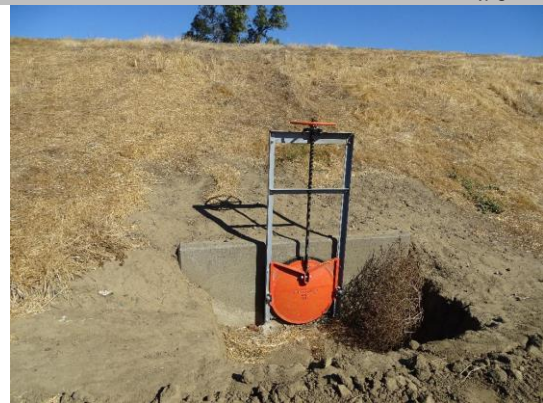
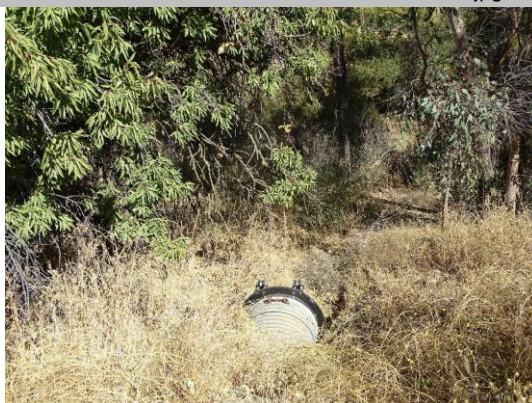
Photo 1 of 3 : UCIP\_FA\_2019\_55450\_81729.jpg

View of LS looking from levee crown

LS slope, headwall, and slide gate

Comment Code						
Inspector Comment						
DS_ID:16642 FS_ID:55450 EP_NO: 10265 Repair Type: Non-Urgent Crossing Status: Found UCIP Comments: 10/21/2019 No issues recorded during inspection (O.Yakimov - DWR UCIP)07/12/2019 After reviewing the USACE O&M manual as-builts there is no reference to this 30-inch pipe. Will need to coordinate with previous UCIP inspector to determine if additional information is available to tie pipe to USACE O&M manual. (O. Magana - DWR UCIP) 04/10/2019 There is no more debris around pipe. And is now sprayed and maintained. (J. McCabe - DWR Sacramento yard) 04/01/2019 Debris buildup at WS outlet. FIELD_STRUCT_DESC: 30-inch CIPP-lined drainage pipe of an unknown material through the levee, 17 feet below the crown. Headwall and slide gate on the landside (LS) end. Flap gate on the waterside (WS) end, 120 feet to the north of the crossing. (36-inch pipe [HLM 6.50] authorized under Automatic Board Order (ABO) issued as Permit No. 10265, 1974 - State of California, Division of Highways. Also included in Automatic Board Order (ABO) issued as Permit No. 11296, 1974 - Capitol National Bank of Sacramento and Crocker Citizens National Bank). [Additional Reference(s): DWR Levee Log, 2005, 36-inch pipe listed. USACE Sacramento O&M Manual 119, December 1952]. FS Date: 10/21/2019 2:11:00 PM

Pipe end on WS

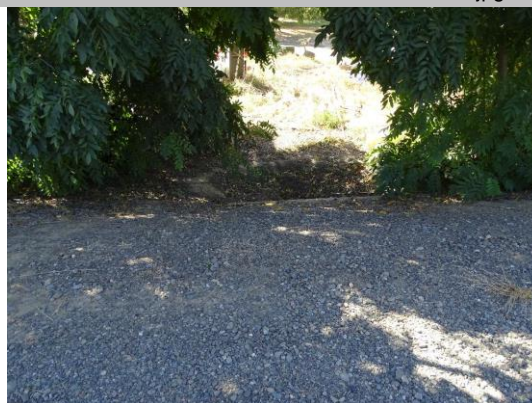
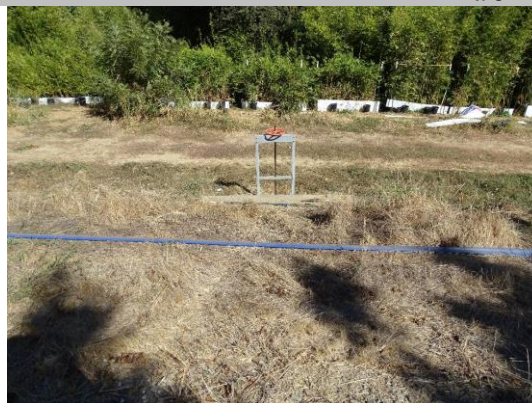
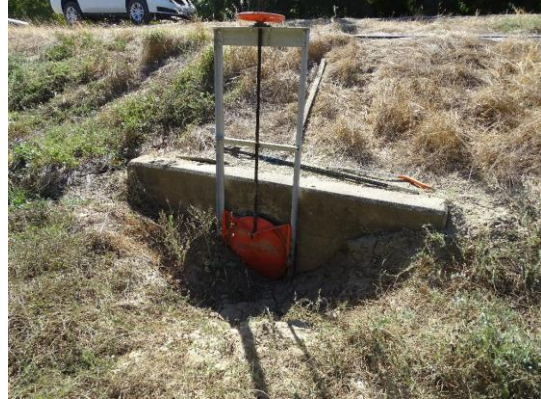
Photo 1 of 3 : UCIP\_FA\_2019\_55452\_81739.jpg

View of LS looking from levee crown

View of WS looking from levee crown

Comment Code						
Inspector Comment						
DS_ID:16633 FS_ID:55452 EP_NO: 10276 Repair Type: Non-Urgent Crossing Status: Found UCIP Comments: 10/21/2019 Minor sediment builtup at slide gate. (O.Yakimov - DWR UCIP)05/22/2013 Will contact owner of pipe and ask to clean for inspection. (C. Lund - DWR Sacramento Yard) 04/05/2012 Pipe heavily clogged with soil. (W. Wylie - DWR UCIP) FIELD_STRUCT_DESC: 24-inch CIPP-lined drainage pipe of an unknown material through the levee, 6 feet below the crown. Slide gate on the waterside (WS) end, and headwalls on both ends. (24-inch pipe [HLM 6.83] authorized under Automatic Board Order (ABO) issued as Permit No. 10276, 1974 - Patricia Schlabes). [Additional Reference(s): DWR Levee Log, 2005 (HLM 6.83). USACE Sacramento O&M Manual, Unit 119, December 1952, Revised 29 Dec 2016, (Station 237+50 PCT). USACE As-Built Drawing No. 50-04-2396, Revision 2, pdf page 26, Sheet 10, December 1947]. FS Date: 10/21/2019 2:32:50 PM

WS levee slope, headwall, and slide gate
